From Glory to Ruins and Back – Conservation at the Mumbai Caves Since the Late 1800s

Brinda Gaitonde Nayak

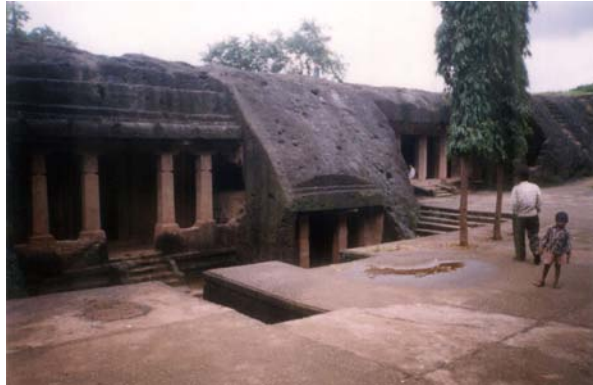
Figure 3: The small complex at Mahakali is evocative of a tiny monastic hamlet in pristine natural setting.

The Mahakali caves, another Buddhist site, were excavated in between the 2nd and the 6th centuries in two groups on a hillock that used to overlook a few water bodies and undulating grasslands. Currently this group of caves, comprising of 4 caves along one mountain face and 15 (Figure 3) on the other side, overlooks a dense squatter settlement and the high powered

multi-billion dollar software hub of Mumbai. This disparity of land use and economic fortunes is reflected in this site's treatment, as it gets routinely ignored for conservation measures in lieu of its more prolific cousins. The most significant excavation at Mahakali is the uniquely shaped *chaitya* cave or prayer shrine with its singular plan form.

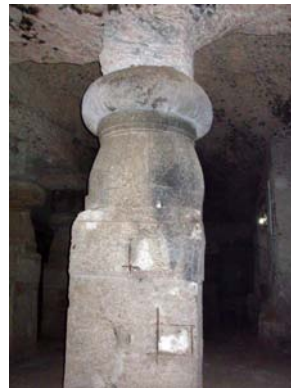
*Figure 6: Corrosion of steel within the repaired matrix
gave rise to eventual issues of splitting and spalling*

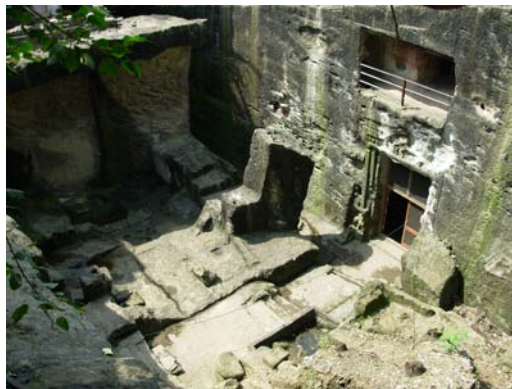
Figure 7: It was the first time in decades that the courtyards of Jogeshwari were exposed again after piled debris and dirt was removed.

The challenges with Jogeshwari have been uphill and the conservators had to face stiff opposition from the locals, who are faced with eventual relocation. One of the first actions was the removal of tonnes of garbage from the cave top; the operation lasting several days with over 9 trucks of debris removed (Figure 7). A drain on top of the cave was isolated and realigned so the issue of percolating water has been resolved. The next step is removal of the most critical slums directly affecting the cave structure, which is proving to be a thorn in the flesh, as there is much political backing against this move. Careful restoration in the form of cleaning using poultice applications at vulnerable areas has been initiated. Since sufficient evidence directly indicating the benefits of consolidants on exterior surfaces under diverse and uncontrolled conditions is not available, surface applications have not been approved as yet. These and other actions are part of the conservation plan which aims to provide a much needed respite and a fresh lease of life for these tormented and priceless monuments.
